### Inspection Report Minerals Regulatory Program February 20, 2013

<b>Mine Name :</b> Carr Fork – Pine Canyon	<b>Permit Number:</b> M/045/0004
<b>Operator Name:</b> Kennecott Utah Copper	<b>Inspection Date:</b> March 10, 2011
<b>Inspector(s):</b> L Heppler, Peter Brinton	<b>Time:</b> 3:00 pm
<b>Other Participants:</b> Zeb Kenyon - Kennecott	<b>Mine Status:</b> Inactive

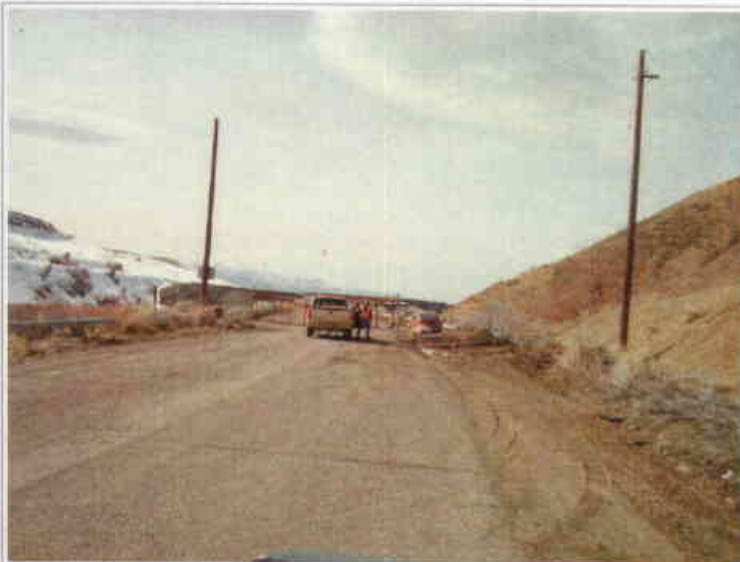
Gate

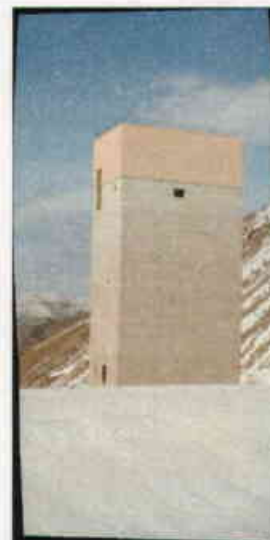
Head frame for shaft

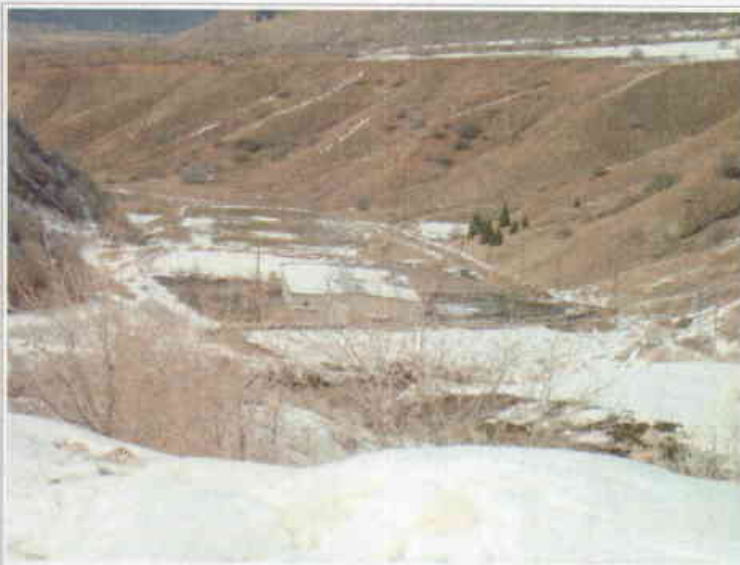
Overview of the warehouse

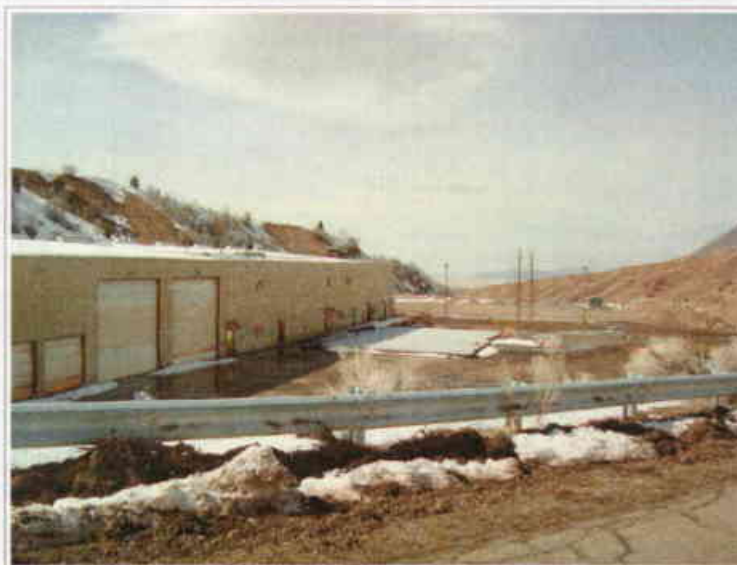
Close up of warehouse
